Technical Notes

The Study of the Influence of the Ceiling Structure on Acoustics in Contemporary Churches

Anna SYGULSKA

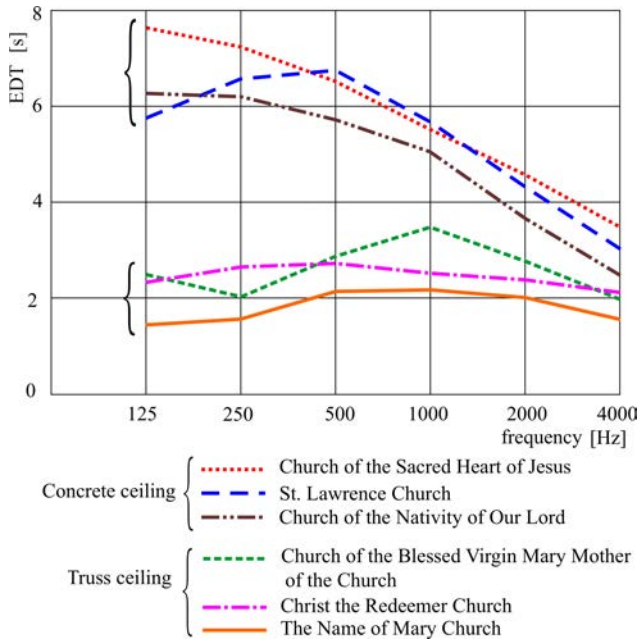
Fig. 4. Early Decay Time EDT – comparison of the churches.

The mean EDT value for the investigated churches is slightly lower than the mean T_{30} value, and for one of the investigated churches, i.e. NM, it takes the same value. For the 500–1000 Hz band, with the exclusion of HJ, T_{30} and EDT values are identical. Characteristics of frequencies for the two parameters in all the investigated churches are very similar. Figure 4 presents characteristics of frequencies for EDT for the churches.

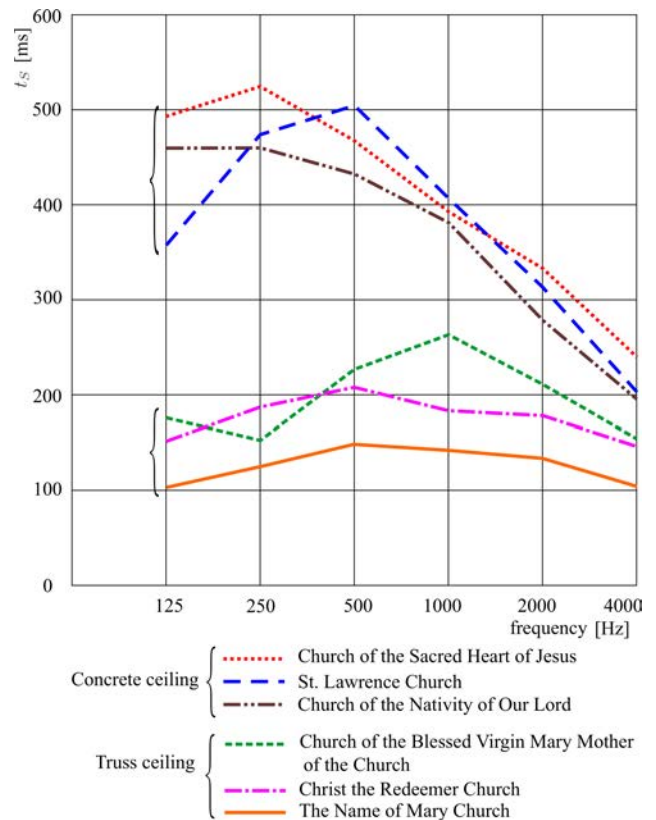
Fig. 5. Center Time t_S – comparison of the churches.

Values of parameter center time t_S in all the churches exceed recommended values. It should be highlighted that the parameter is particularly un-

favourable in buildings with a concrete ceiling. The mean value t_S in the buildings ranges from 367 ms to 408 ms (in HJ), while the extreme recommended value is 120 ms (WRÓBLEWSKA, KULOWSKI, 2007). The values considerably exceed the permissible value for organ music, which is 180 ms.

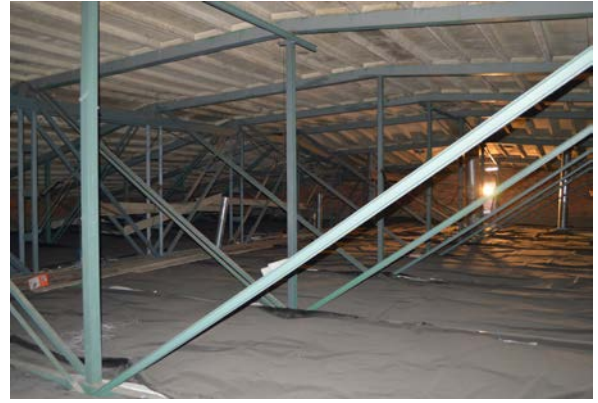
Fig. 10. Inside the ceiling of church VM.

loosely placed on a steel frame lined with polyethylene sheeting. Along with thin aluminum tiles, the polystyrene constitutes a transodent layer. Figure 10 shows a photo of the inside of the ceiling. The foreground features vertical and cross members; reinforced slabs are placed on the top member of the truss, with polyethylene sheeting placed on the bottom member of the truss.
