ACOUSTIC EXAMINATION OF EPOXY-GLASS INSULATOR MATERIAL

Ultrasonic, microscopic and acoustic emission (AE) methods were applied to investigate the microstructure of composite rods, used as a carrying element of the medium voltage insulators. Such features of material structure as homogeneity level and the appearance of defects were discussed. The research was aimed at determining the influence of the technology of epoxy-glass fabrication on quality parameters of the insulator rods. The results of acoustic testing were compared with the effects of microscopic investigation.

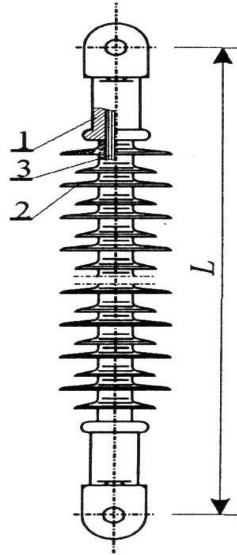
Fig. 1. The typical line composite insulator: 1 – metal fixing devices situated at both ends, 2 – the polymer cover with formed sheds, 3 – the glass-epoxy carrying rod [4].

The typical line composite insulator consists of three elements, as it is shown in Fig. 1: metal fixing devices situated at both ends; the polymer cover with disc sheds and the glass-epoxy insulating rod. The rod acts as a hard core to endure the mechanical load and voltage gradient. The synthetic rubber cover with sheds ensures the desired leakage path and rain spark-over voltage [3, 4].

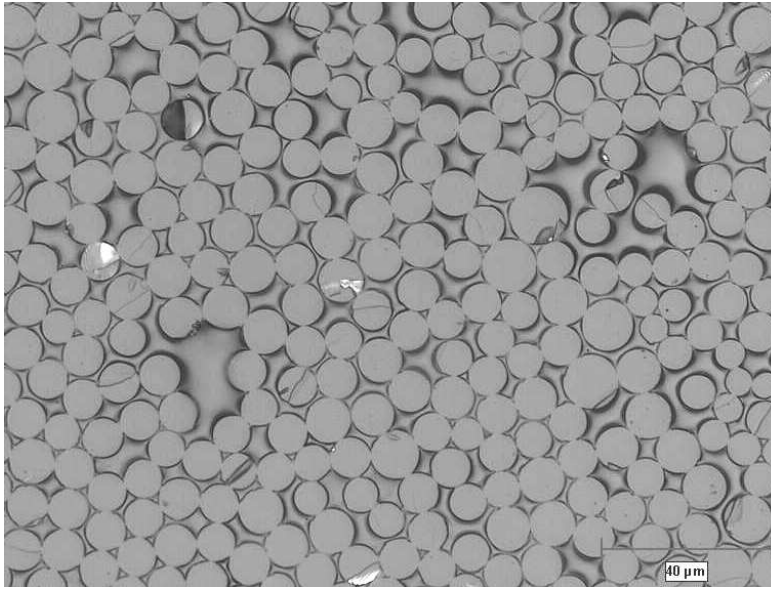
Fig. 4. The typical microscopic image of composition B structure. Sufficient homogeneity and small number of internal cracks of roving fibres are visible. Magnification $\times 200$.

However, these defects occurred more frequently in composition A and only incidentally in material B. The typical microscopic images of both materials are shown in Fig. 3 – composition A and in Fig. 4 – material B.

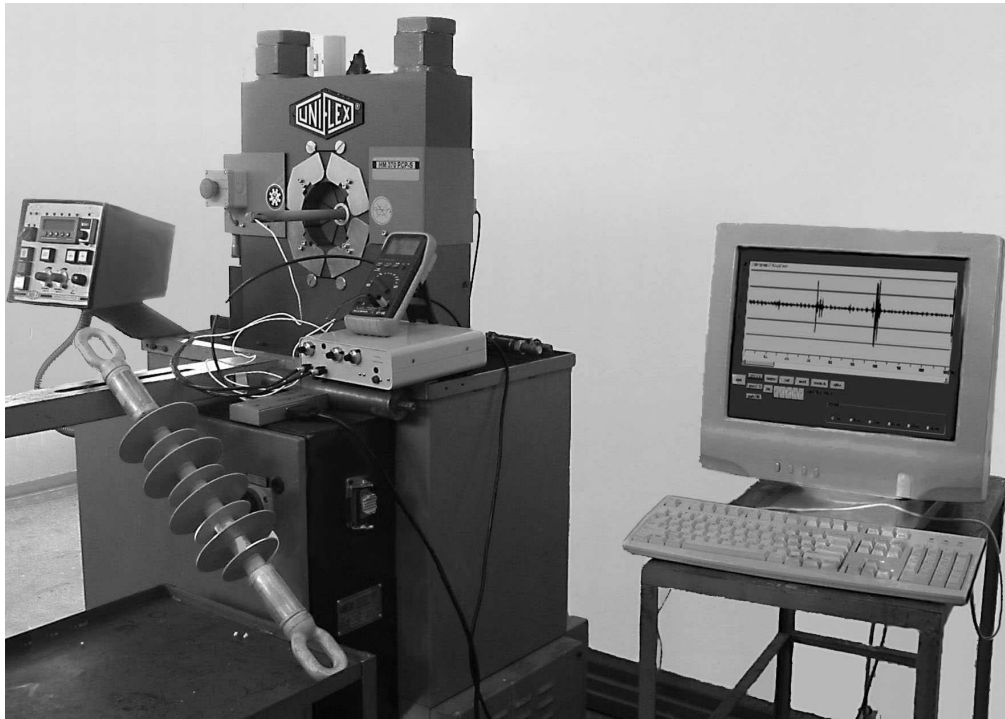
Fig. 5. View of the experimental set-up used to AE control the process of compressing the fixing devices on the medium voltage insulator rod.

Besides microstructural and ultrasonic measurements, the process of compression of the fixing devices on the carrying rod was investigated. This process was performed by a hydraulic press. Compression was realized by automatic multi-element jaw. Direct on-line control of the pressure acting on the carrying rod is difficult. Compressive forces acting on both ends of the rod are analogous. Therefore only one end of the rod was controlled during compression, while to the other end the wideband acoustic emission sensor WD Physical Acoustic Corporation type was coupled. The passband of AE transducer was between 80 and 1000 kHz. Transducer was connected with a preamplifier and AE analyzer, coupled with the computer. The applied instrumentation is shown in Fig. 5, presenting the composite medium voltage line insulator with installed fixing devices. In the central part of the picture there is a carrying rod with fixing device placed in the jaws of the hydraulic press. To the other end of the rod the acoustic emission sensor is connected.

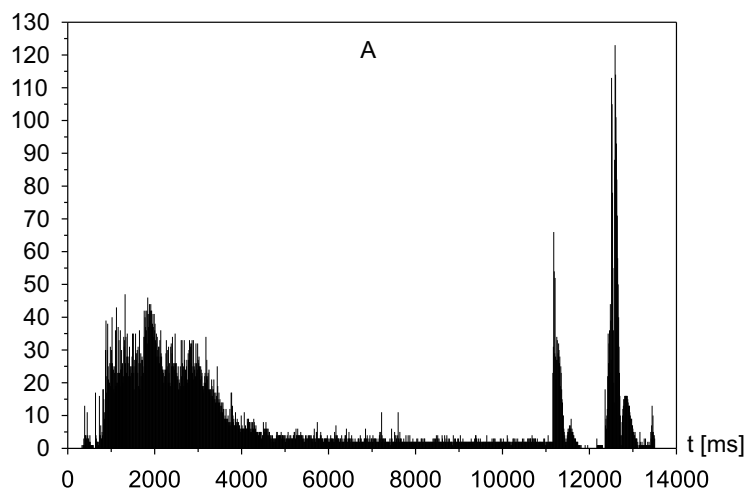
Fig. 6. Time dependence of AE RMS signals, generated in material of type A during fixing device assembly to the insulator rod.

devices. Experiments were carried out using pressure 17 MPa. The effective values of acoustic emission signals (RMS) generated during compression were registered. The typical time dependence of RMS signal is shown in Fig. 6 (epoxy-glass A) and in Fig. 7 (material B). The whole process can be divided into three stages. During the first stage of the process (4–4.5 s) the compression increased linearly to the value of 17 MPa. During this preliminary stage, a high acoustic activity was generated. Course of the AE activity in this stage was similar for all experiments. This is a consequence of the analogous effect of plastic deformation of metal fixing device. Metal deformation has been recognized as the source of AE signals. In two next stages the compression was maintained at constant level 17 MPa. During the second stage, AE activity remained at low level. The strong acoustic signals were generated in the last stage – after eleventh second. They originated from the deformed structure of the epoxy-glass rod. The high RMS value of AE signals can be result of cracking of roving fiberglass in the structure of composite material. Experiments showed a remarkable difference in the course of acoustic energy emission generated by the rods of type A and B. The amplitude of the signal generated by the structure of type A – two bursts, was approximately two times greater than that of type B – one burst. These results indicate lower mechanical strength and higher number of structural inaccuracies of epoxy-glass material of type A.

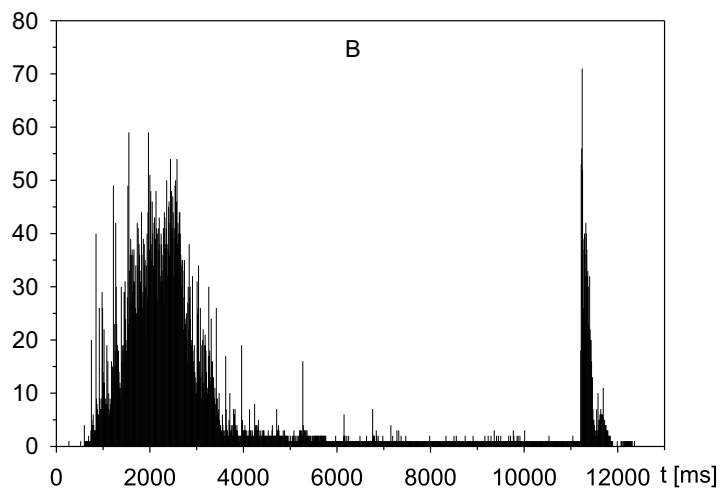
Fig. 7. Time dependence of AE RMS signals, generated in material of type B during fixing devices assembly to the insulator rod.
