# Technical Possibilities of Reducing the Sound Pressure Level Emitted into the Environment by a Power Transformer

Sebastian BORUCKI, Tomasz BOCZAR, Andrzej CICHON

*Opole University of Technology*  
*Institute of Electric Power Engineering*  
Prószkowska 76, 45-758 Opole, Poland  
e-mail: {s.borucki, t.boczar, a.cichon}@po.opole.pl

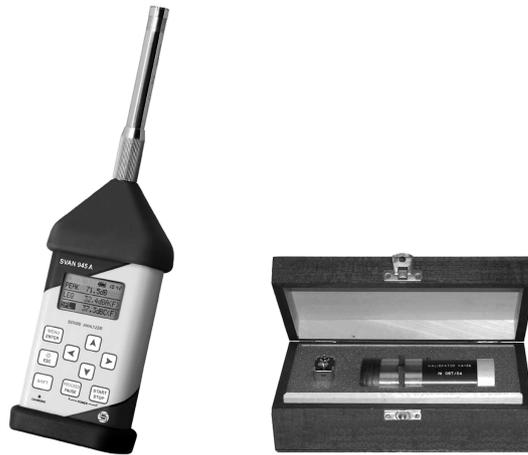
Fig. 1. Overall view of the measuring apparatus used.

The measurements of the corrected sound pressure level ( $L$ ) were taken with a meter type 945A by SVAN. This appliance is meant for taking measurements of the noise level with accuracy corresponding to class 1 and for a frequency analysis of the signals in the band 1 Hz – 20 kHz. A KA-50 calibrator by Sonopan was used for the calibration of the measuring instrument used. Figure 1 shows an overall view of the measuring instrument used.
