# FAULT DIAGNOSTICS OF THE FUEL INJECTION SYSTEM OF A MEDIUM POWER MARITIME DIESEL ENGINE WITH APPLICATION OF ACOUSTIC SIGNAL

The possibilities of application of a portable system for registration of the acoustic signal in the frequency range of 1000–10000 Hz for diagnosing common faults of the fuel injection system of the maritime diesel engine are presented. Clear differences in the registered waveforms are occurring when the records of the working fuel injector are compared with the other ones recorded in the injector with blocked nozzle orifice and when insufficient amount of fuel is delivered. Signal signatures of the operating fuel pump at three operating conditions are also presented. A procedure of comparing the acoustic signals registered on the stub of similar faulty and good engine elements is recommended by the authors as efficient and easy for application.

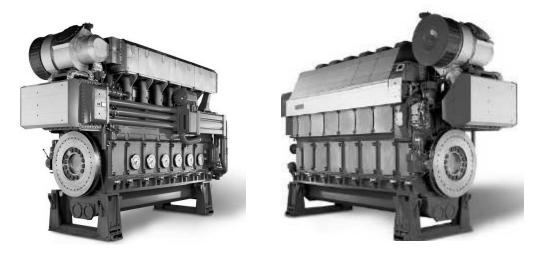
Fig. 1. A 3960 kW four-stroke medium speed Wartsila SW 380 diesel engine used in the investigation.

occurrence of fault signatures in the frequency range of 25–10000 Hz [5]. The latter method was chosen by the authors of the paper to make the experimental work, however the analysed frequency range was modified to suppress the low frequency components generated by the crank vibrations and combustion pulses. The object of examination was a 6-cylinder 3960 kW four-stroke medium speed Wartsila diesel engine presented in Fig. 1. A custom–made portable signal monitoring equipment has been used. The equipment consisted of:

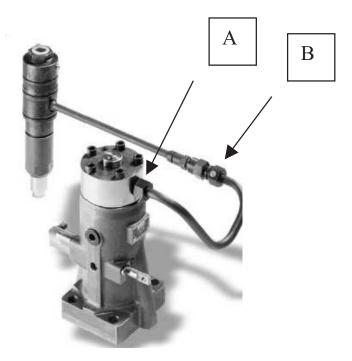
Fig. 2. Placement of the acoustic sensor for monitoring the signals generated by the fuel pump (A) and the injector (B).

The bandpass filter and amplifier was equipped with a RMS converter. Measured signals were registered after conversion to the RMS value in a form of a signal envelope. The waveforms shown in the paper are presented under a system voltage gain set to 26 dB (20 X). Acoustic signal was registered in two locations: on the stub outlet of the injection pump (A) for monitoring the signals generated by the pump and on the stub inlet to the injector (B) for monitoring the signals generated by the operating injector. Placement of the acoustic sensor is shown in Fig. 2.

The acoustic waveforms of the registered signals presented below and stored in location A and location B are different, what is a proof that a sensor placed in location A registers the signatures of the operating fuel pump and that placed in location B registers the signatures of the working injector.

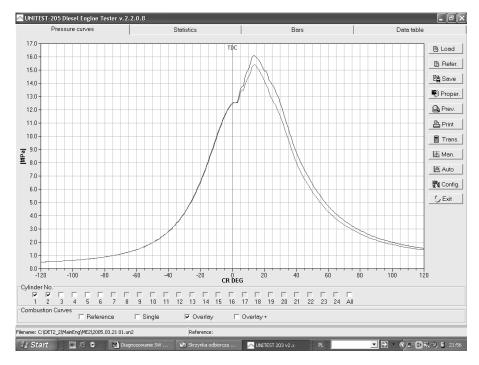
Fig. 3. A pressure trace registered in the faulty cylinder (upper curve) and the trace registered at correct injector operation (lower curve). The records produced with application of UNITEST 205 diesel engine tester.

A fault was recognised in one injector of the tested engine. The nozzle orifice of the injector was blocked with products of fuel combustion – the obstruction exceeded 50% of the orifice area. This fault had no effect on the operation of the entire engine because its governor section would attempt to increase the fuel supply to the remaining cylinders in order to produce the same amount of power. That procedure disadvantageously rises the overall engine fuel consumption. A pressure trace from the faulty cylinder demonstrates the pressure pulse delayed in time domain when compared to the trace registered in the healthy one (vide Fig. 3).
